**AMERICAN WATER RESOURCES ASSOCIATION-  
WISCONSIN SECTION**

# Evaluation of Natural Attenuation at Closed Wisconsin Leaking Underground Storage Tank Sites

Authors: R.M. Greve, J.M. Bahr, T.  
Evanson, A. Pelayo, D.W. Hall, J. Skinner

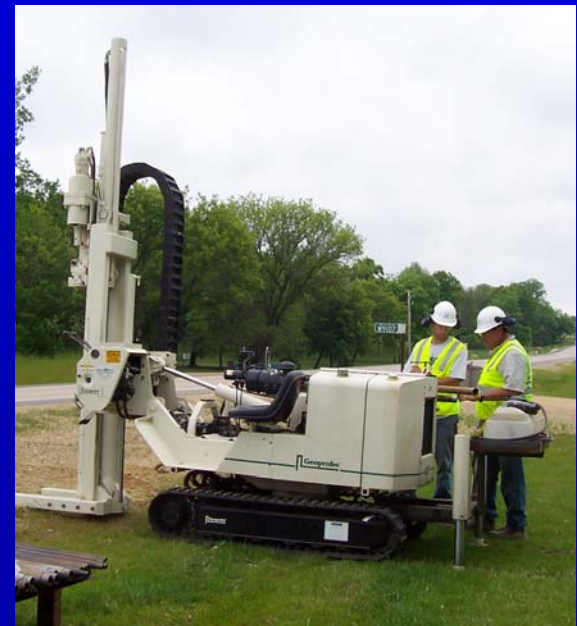
# Field Sites

## Selection Criteria – 10 Field Sites

- Down-gradient wells sufficient to define historic plume dimensions
- Sufficient wells to determine historic ground water flow direction
- Representative geographic distribution around Wisconsin
- Site Access !!

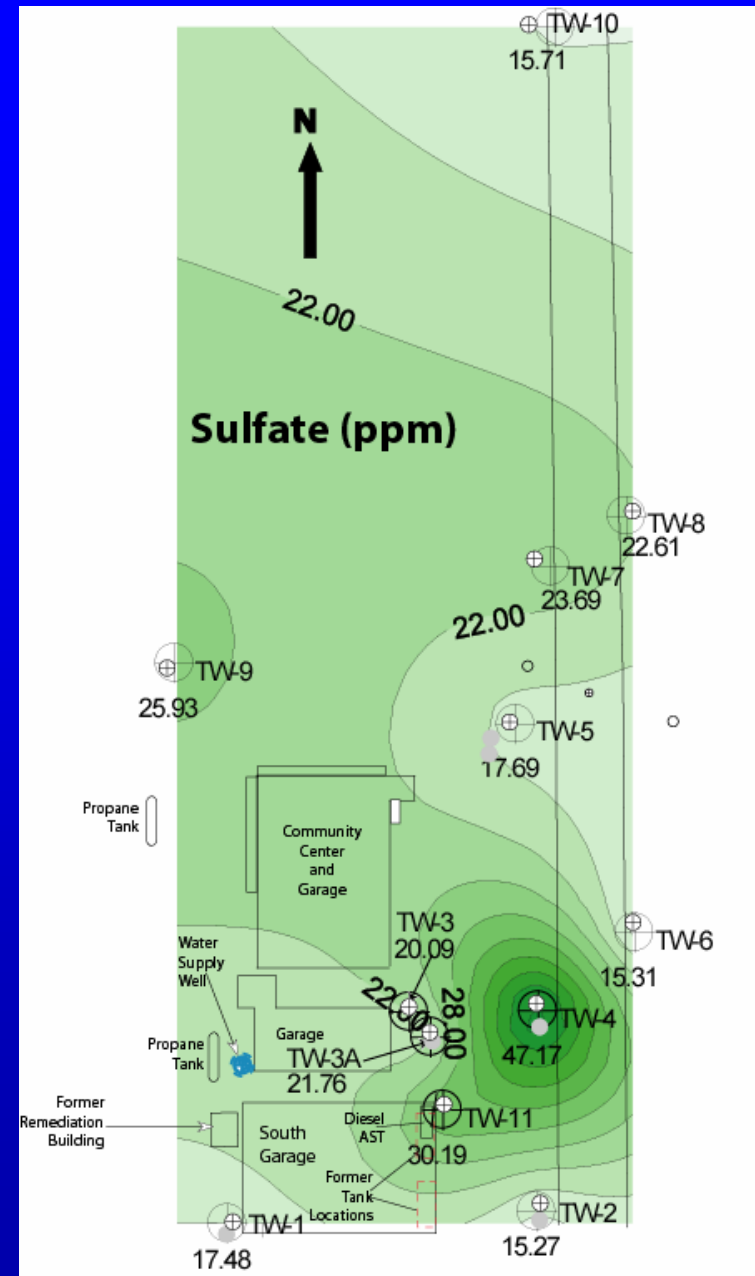
- Sulfate reduction expected after oxygen depleted; expect low SO<sub>4</sub> near source area
- Readings show no evidence of sulfate reduction
